EYEON HOME REPORT

13 West Street Dover Heights NSW 2030

DATE OF ASSESSMENT: 12 JUNE 2017

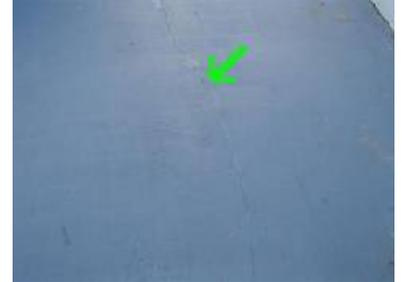
The concrete driveway is in fair condition. The concrete driveway has some visible cracking that should be monitored for further movement.

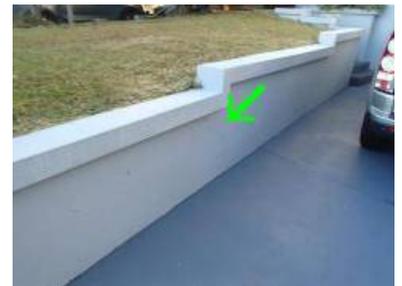
The masonry retaining walls show deterioration, cracks etc, and should be monitored for additional movement.

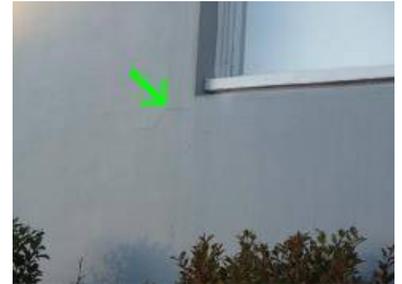
Front elevation.

The condition of the walls is generally acceptable. Cracks are evident to masonry. Visible cracking appears minor. Periodic maintenance may be required. Please refer to section of this report - CRACKING OF BUILDING ELEMENTS for additional details. Paint deterioration was noted to external surfaces. Maintenance and or repairs will be required.

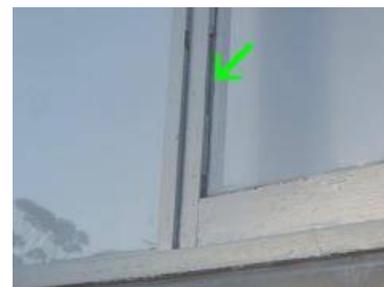
The condition of the exterior of the windows is generally fair. Putty in the windows has deteriorated and requires attention.

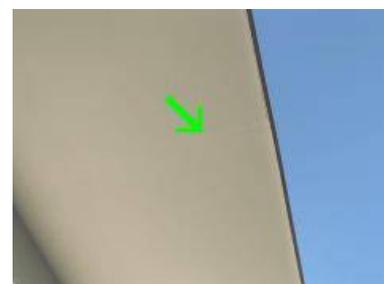
Ceiling/soffit lining is defective or damaged and requires repair and or maintenance.

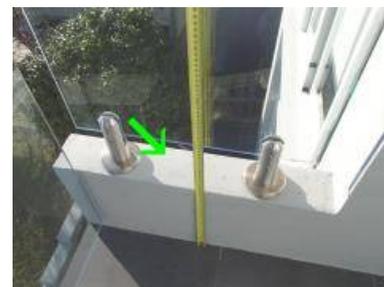
The handrails and balustrades no longer comply with the current Building Code for height and or spacing. Changes to the Code of this nature are generally related to improved safety. Gutters and or downpipes are not present to this roof area to direct water into the stormwater, street kerb or retention system. Recommend guttering be installed to comply with the current Building Code.

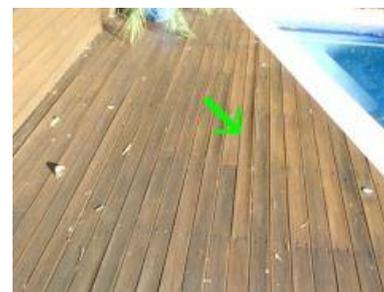
Timber flooring is loose and requires re fixing. Some timbers of this structure are in contact with or close to soil. This situation can cause moisture issues and decay and may also allow concealed termite entry. Recommend modifications be made. Minor maintenance and or repairs are required prior to next repainting.

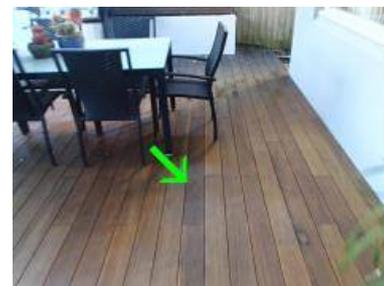
Some timbers of this structure are in contact with or close to soil. This situation can cause decay and also allow concealed termite entry. Recommend modifications be made.

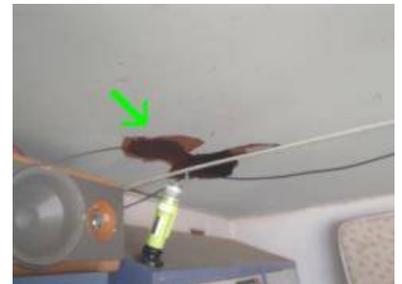
The condition of the ceilings is generally fair. Impact damage was noted to some ceiling surfaces.

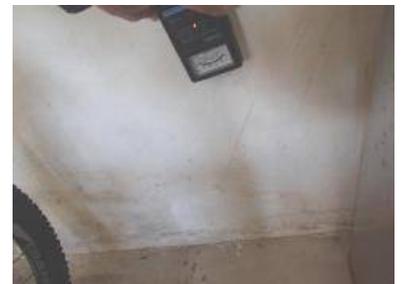
The condition of the walls is generally acceptable. Evidence of minor lateral damp was noted. This may be the result of a cavity bridge, plumbing leak or other undetected defect. This situation should be monitored.

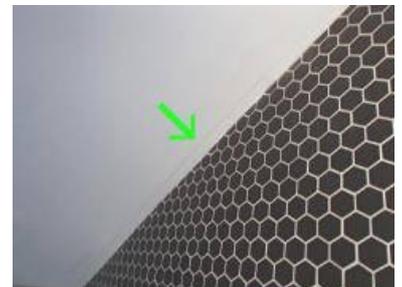
The condition of the ceiling area is generally acceptable. Poor joint setting was noted to ceiling lining.

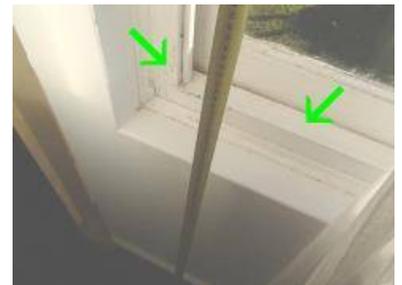
The condition of the windows is generally fair. Paintwork to the windows has deteriorated and maintenance is required. Window sill height is low and may be hazardous. Recommend a safety rail be installed or modifications be made to prevent injury.

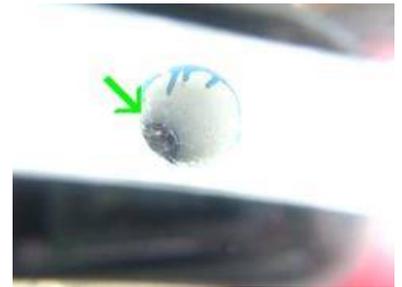
The floor waste appears to be discharging below the building. Recommend the waste be connected to the sewage system or directed to discharge to an external area.

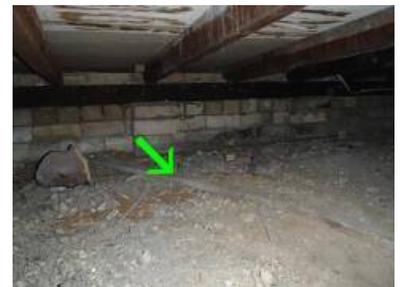
We recommend the removal of loose timbers from the underfloor area as these predispose the property to timber pest attack. The underfloor soil around part garage wall is damp. This may be due to a drainage problem or some other factor. This area should be monitored to determine a cause for the dampness and the problem rectified.

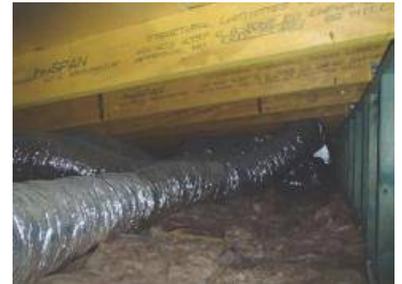
A section of the roof is of skillion type construction and there is no accessible cavity for inspection. Therefore no comment is made regarding the internal roof structure for that section. The cut and pitched roof timbers appear to provide adequate support.

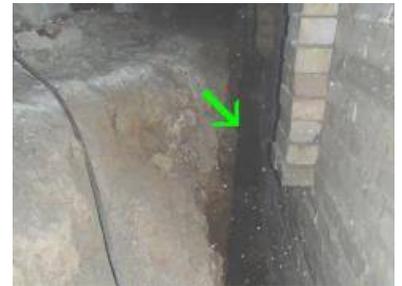
We recommend the removal of loose timbers from the sub floor area as these predispose the property to termite attack. The sub floor soil appears damp around part garage wall. This should be monitored on a regular basis as moist soil conditions are highly conducive to timber pest attack.
