Style of dwelling	Three storey dwelling.
Built about	Circa 1901. The building appears to have had an extension/addition/alteration. The purchaser should contact the local council to ensure that the extension/addition/alteration has been approved and inspected as required.
Footings	The building is constructed on the following footing type/s: Masonry strip and pier. Concrete Slab. Masonry/concrete base and a suspended concrete slab floor. Sandstone block.
External Walls	Full or double brick.
Roof	Slate.
Accommodation	Bedrooms: Five. Bathrooms: Four.
Condition of main building	<b>Please refer to the Building Inspection section of this Report.</b>

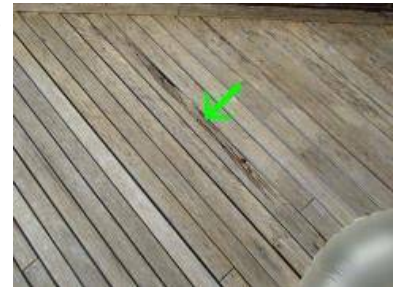
Severe wood decay is present to the structure and decayed timbers should be replaced.

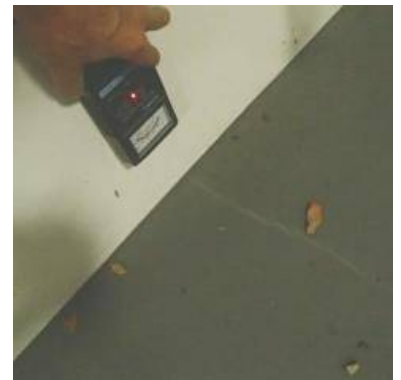
The condition of the walls is generally acceptable. Evidence of lateral damp was noted. This may be the result of a cavity bridge, plumbing leak, inadequate drainage or other undetected defect. This situation should be rectified.

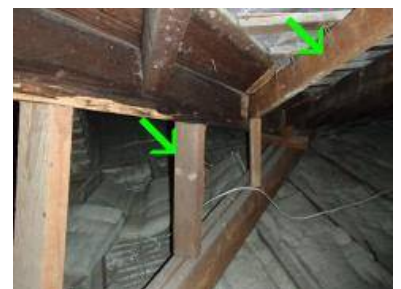
Some timbers (listed below) appear to be new or not the original timbers. This replacement may have been due to timber pest attack or some other factor. We recommend if you are using this report to purchase this property, further enquiries should be made to determine the reason for timber replacement.

Rafters. Valley board timbers. Top wall plate timbers.
