EYEON HOME REPORT

1 Sample Street Sydney NSW 2000

DATE OF ASSESSMENT: 1 JUNE 2018

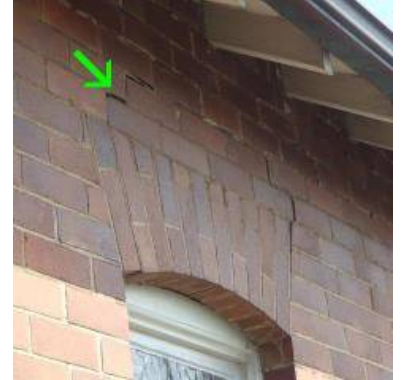
The condition of the walls is generally acceptable. Cracks are evident to masonry. Visible cracking appears minor. Periodic maintenance may be required. Please refer to section of this report - CRACKING OF BUILDING ELEMENTS for additional details.

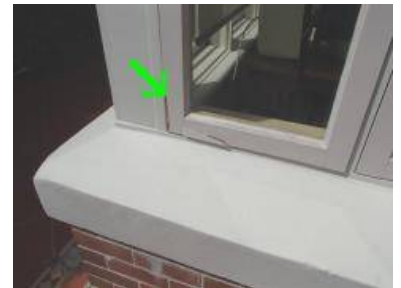
The condition of the windows is generally acceptable. Minor maintenance and or repairs are required.

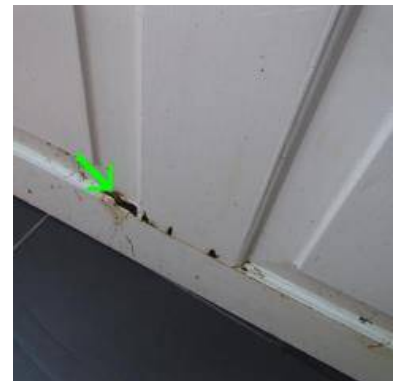
The condition of the exterior of the doors is generally acceptable. Wet rot decay is present to the rear lower bathroom door and damaged timbers will require repair or replacement.

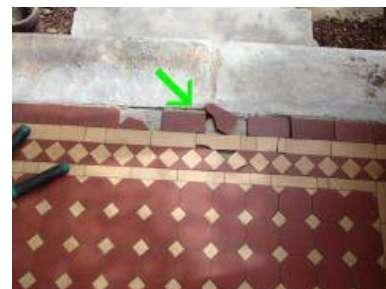
Cracked and drummy floor tiles are present and may require repair or replacement.

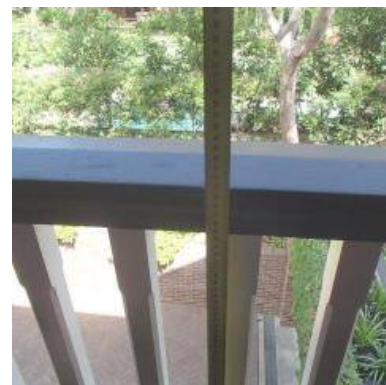
The handrails and balustrades no longer comply with the current Building Code for height and or spacing. Changes to the Code of this nature are generally related to improved safety.

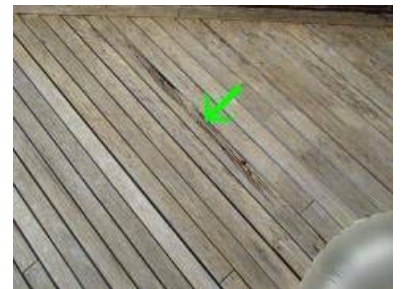
Severe wood decay is present to the structure and decayed timbers should be replaced.

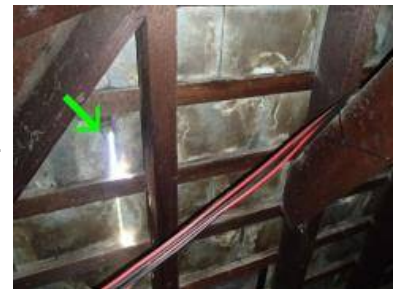
The overall condition of the roof coverings could not be determined due to limited access. Roof and/or flashings are allowing water to penetrate the interior of the building. Concealed internal roofing members may be damaged and require repair or replacement. This should be investigated further by a licensed contractor and rectified. The slate is deteriorating in some areas. A roof slater should be engaged to carry out necessary repairs or replacement.

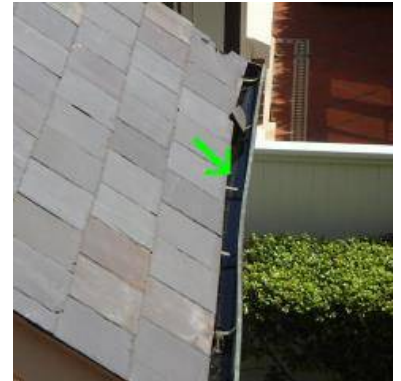
Appear to be in serviceable condition. Water is ponding in some gutters. Realignment of the gutters is required.

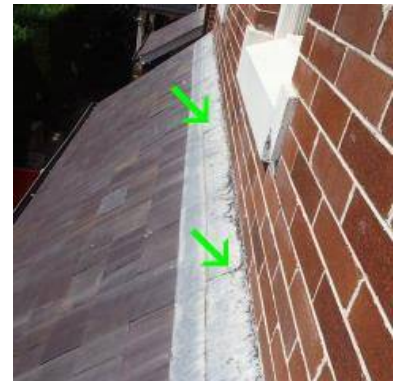
Flashing material is of lead. Flashing is split, in poor condition and will require rectification to the following areas:

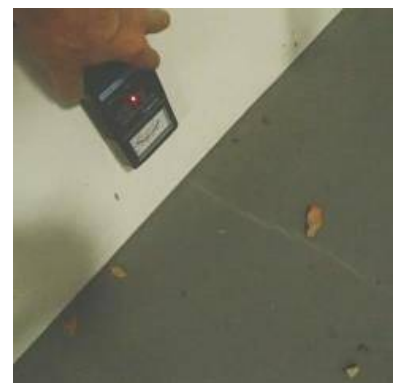
The condition of the walls is generally acceptable. Evidence of lateral damp was noted. This may be the result of a cavity bridge, plumbing leak, inadequate drainage or other undetected defect. This situation should be rectified.

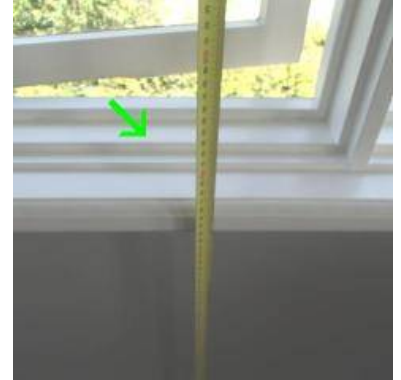
The condition of the windows is generally acceptable. Window sill height is low and may be hazardous. Recommend a safety rail be installed or modifications be made to prevent injury. Cracked glass is evident and may require replacement.

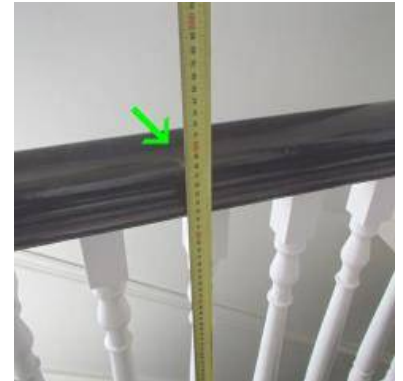
The stairs are constructed from: Timber. The condition of the stairs is generally acceptable. The handrails and balustrades no longer comply with the current Building Code for height and or spacing. Changes to the Code of this nature are generally related to improved safety. Head height over the stairs is low, does not comply with the current Building Code and may be hazardous. Recommend this area be modified.

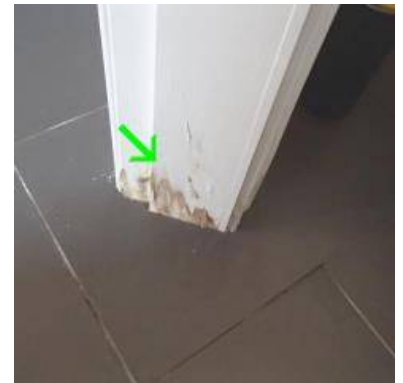
The condition of the woodwork is generally acceptable. Decay or moisture damage was noted to the following timbers and damaged areas will require maintenance, repair or replacement: Skirting. Door jamb. Architraves.

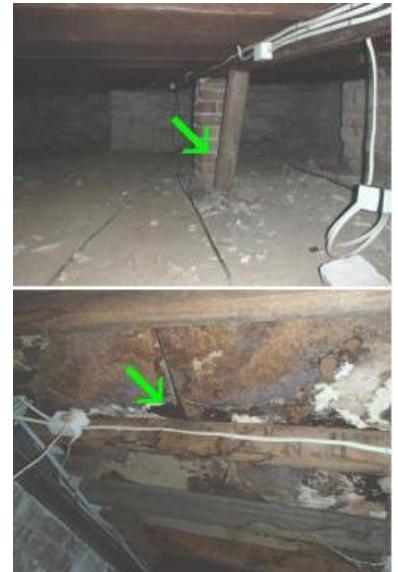
Ant capping is not installed. Ant capping is installed to deter termites forcing them to build their mud tubes around the ant capping enabling detection during inspection. We recommend the removal of loose or stored timbers from the underfloor area as these predispose the property to timber pest attack. Timber floor supports are located to the sub floor of the building. This practice is conducive to timber pest attack and supports should be replaced with brick piers or steel supports. There was evidence of previous water penetration through the flooring and this area may require repair. The leaks do not appear to be active at the time of the inspection. Recommend this area be monitored for further leaking. Some repairs may be required. Cabling to the sub floor area is loose and should be secured to the underside of the floor to prevent accidental dislodgement. Recommend an electrician evaluate further and rectify.

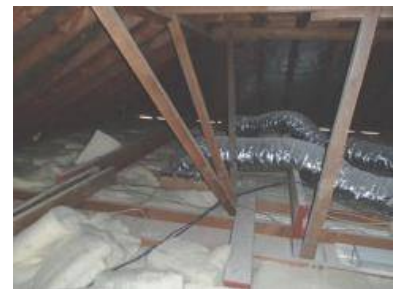
The cut and pitched roof timbers appear to provide adequate support. A potential water leak noted. Refer to external roof. Repair to roof covering or flashings recommended. This area should be continually monitored. If leaking or damage is evident refer to roofing expert.

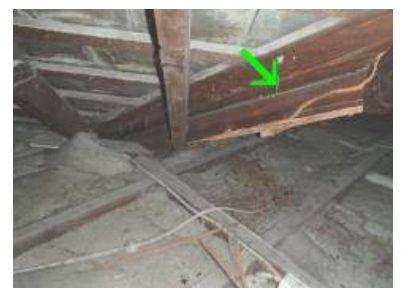
Evidence of what appears to be a timber pest attack was noted. Please refer to pest inspection report for details.

Rafters. Top wall plate timbers. Valley board timbers.

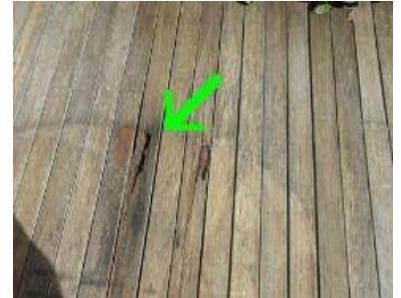
Wood decay damage was noted to the following timbers/areas:

Fencing timbers. Door/s. Decking timbers.

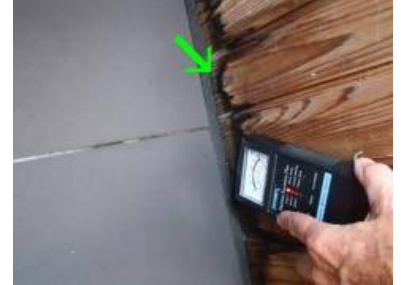
Wood decay damage was noted to the following timbers/areas:

Door frame/jamb timbers. Timber panelling. Skirting timbers.

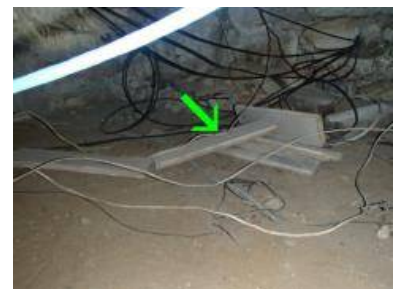
We recommend the removal of loose timbers from the sub floor area as these predispose the property to termite attack. We note the general lack of ant capping or deficiencies in the fitment of ant capping. The purpose of ant capping is to reduce the risk of concealed termite attack. Ant capping should be repaired or installed where possible. Timber supports are present in the sub floor area. These should be replaced with a non timber alternative.

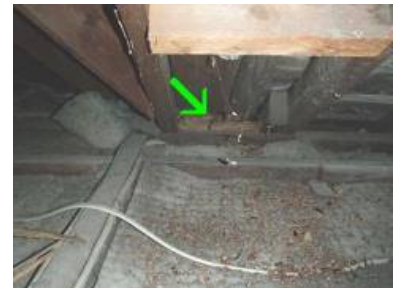
Inspection revealed currently inactive termite attack (damaged timbers and/or termite workings) within this area including but not necessarily limited to the following timbers and the areas listed below.

Rafters. Top wall plate timbers. Valley board timbers.

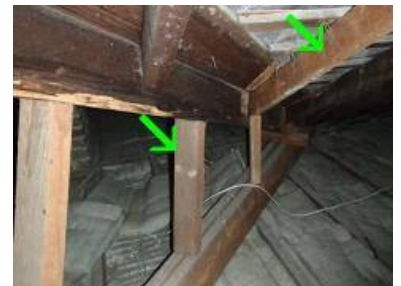
Some timbers (listed below) appear to be new or not the original timbers. This replacement may have been due to timber pest attack or some other factor. We recommend if you are using this report to purchase this property, further enquiries should be made to determine the reason for timber replacement.

Rafters. Valley board timbers. Top wall plate timbers.
