EYEON HOME REPORT

1 Sample Street Sydney NSW 2000

DATE OF ASSESSMENT: 1 JUNE 2018

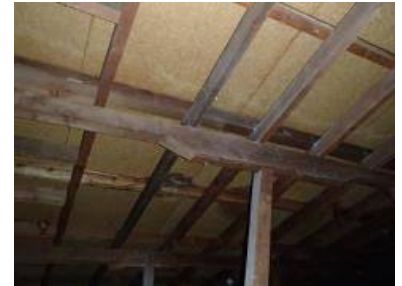
Centre of main roof.

Roof Covering Condition Detail:

The overall condition of the roof coverings could not be determined due to limited access.
